NIST GCR 02-843

Analysis of Needs and Existing Capabilities for Full-Scale Fire Resistance Testing

Jesse Beitel
Nestor Iwankiw
Hughes Associates, Inc.
3610 Commerce Drive, Suite 817
Baltimore, MD 21227-1652

December 2002

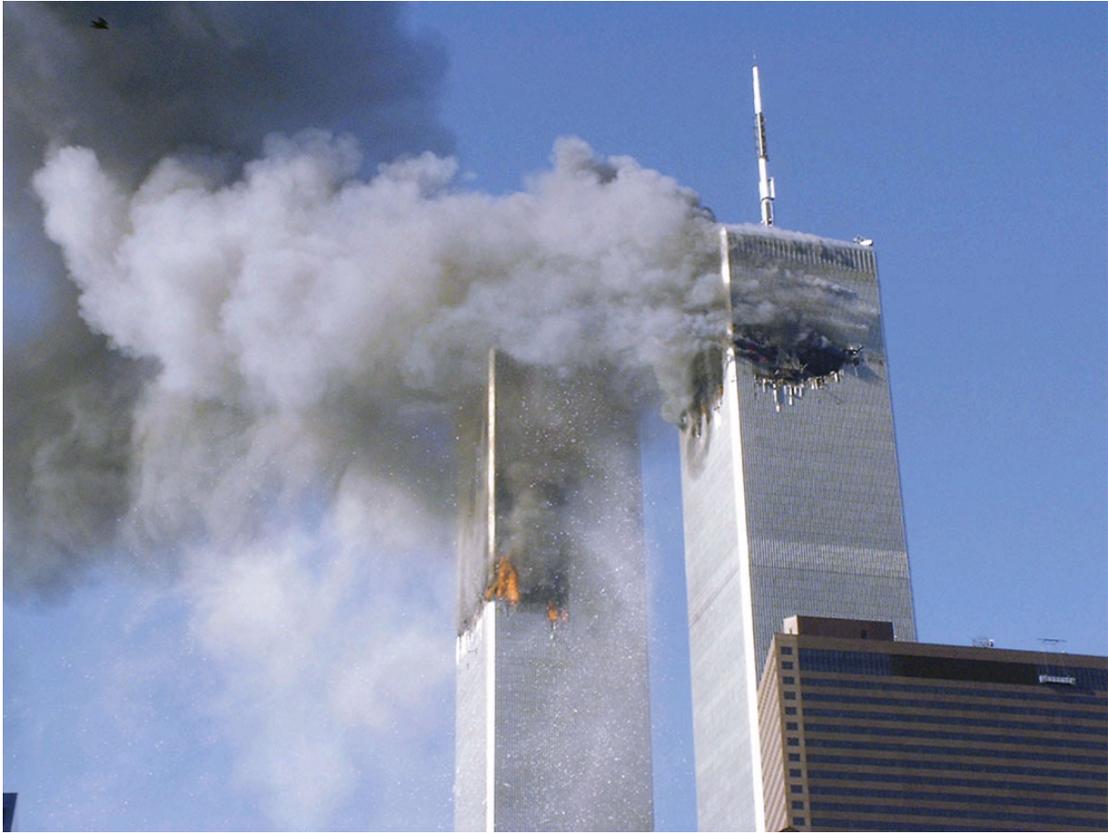
Figure 2.1a Damaged and Burning WTC 1 (right) and WTC 2 (left) on Sept. 11, 2001

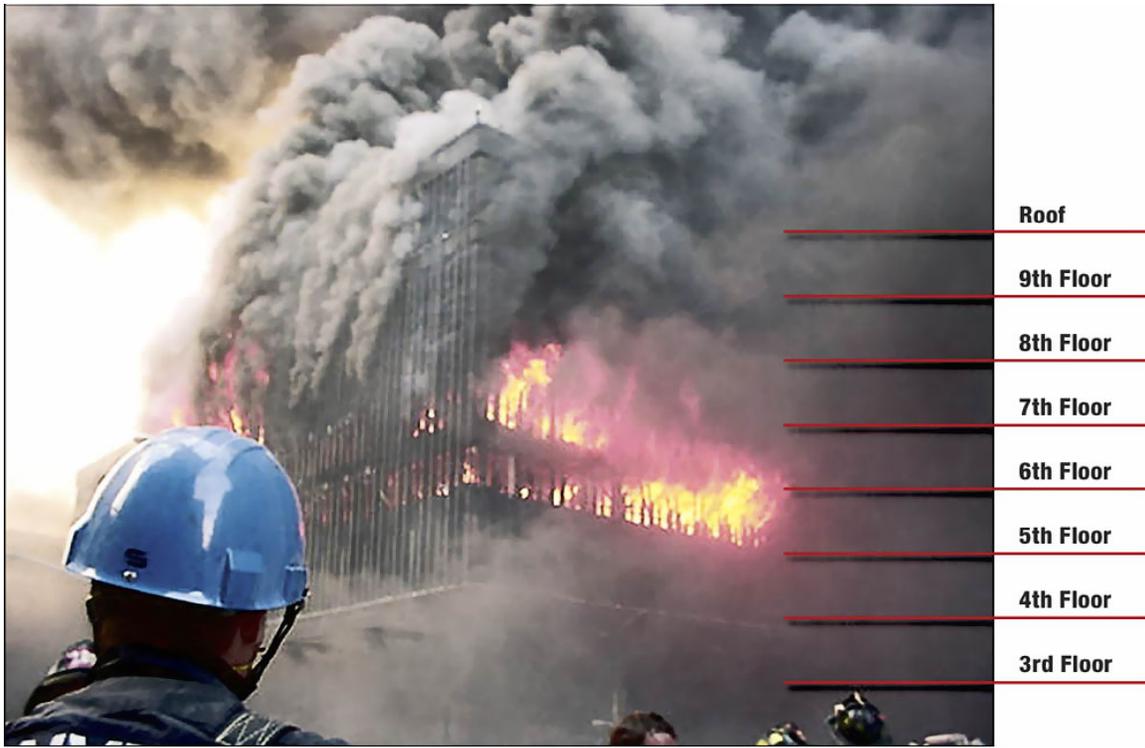
The 9-story WTC 5 building suffered extensive structural damage due to WTC 1 debris, which subsequently led to partial collapses of 4 floors due to fires. Interior floor beam splices

Figure 2.1b Fires in WTC 5

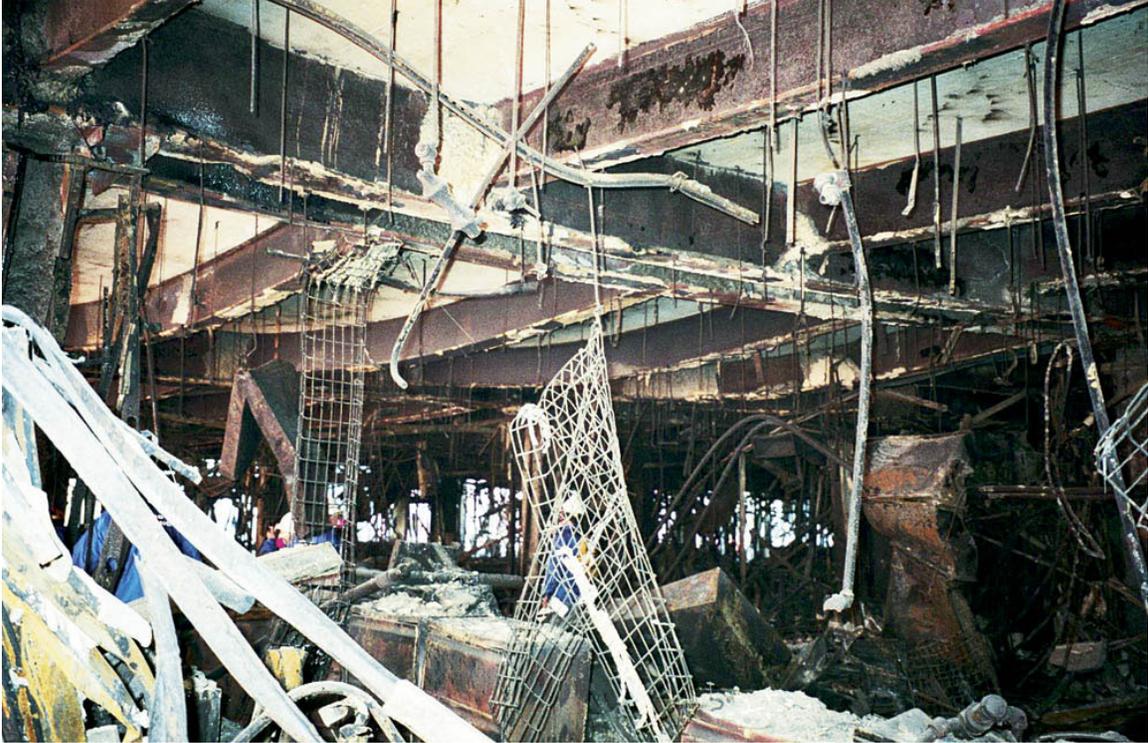
Figure 2.1c Fire Damage in WTC 5

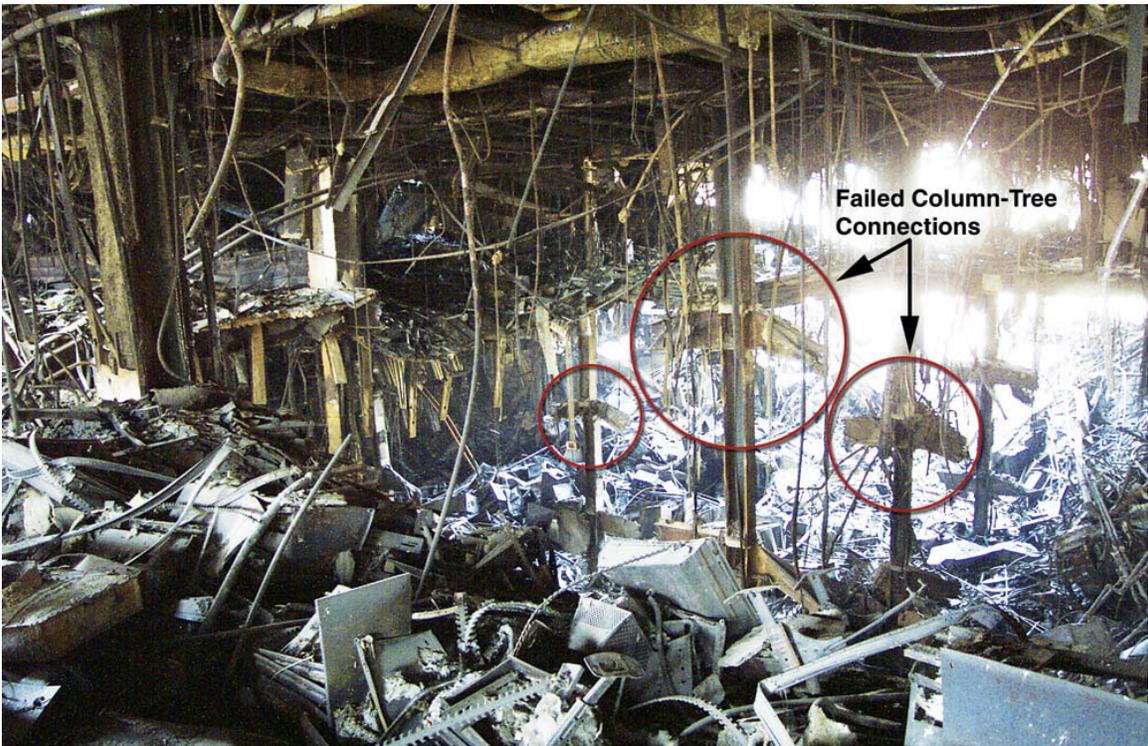
between supporting column-tree stubs and beams were identified as the point of fire-induced failure of these several floor bays.

Figure 2.1d Partial Connection and Floor Failures in WTC 5

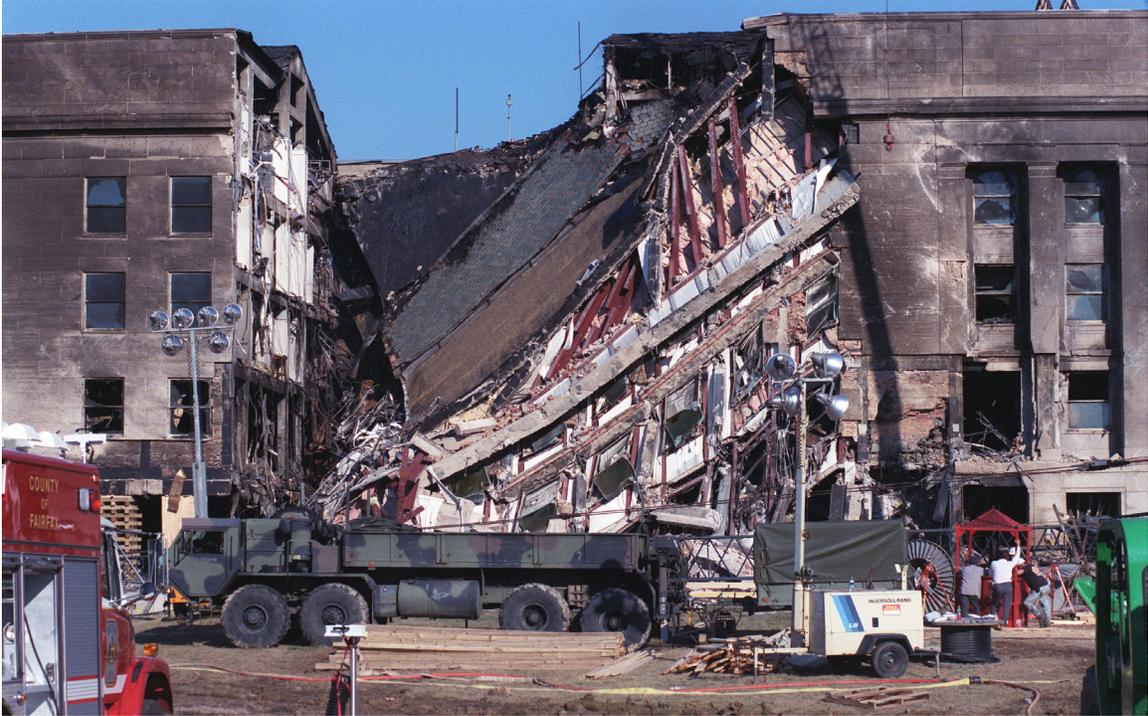
On September 11, 2001 the 5-story Pentagon building in Washington, DC, was struck by an aircraft, resulting in extensive damage and fire (see Figure 2.2). The Pentagon was constructed between 1941 and 1943 of hardened, cast-in-place reinforced concrete. News, anecdotal and visual observations indicate that there were some partial structural collapses in the Pentagon due to the ensuing fires approximately 30 minutes after the jet impact. An official investigation of the incident is being prepared but has not yet been released. There is no other publicly available information on the nature and progression of the structural damage in the Pentagon resulting from the jet crash and subsequent fire.

Figure 2.2 Pentagon Collapse from the Sept. 11, 2001 Attack

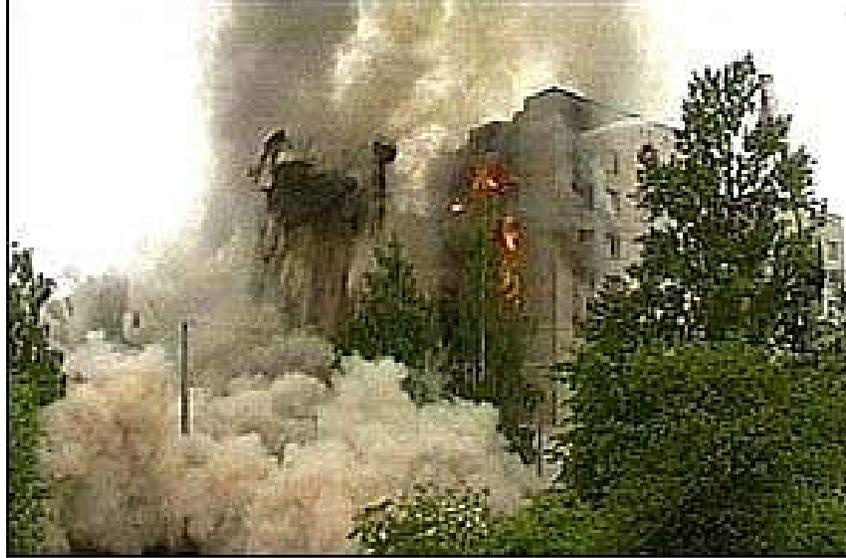
Another recent fire-induced building collapse occurred in St. Petersburg, Russia on June 3, 2002 (BBC News Online, 2002; Ottawa Citizen, 2002). This building was a 9-story concrete apartment block that totally collapsed after about a one hour fire (See Figure 2.3). The news services reported only 1 related casualty, with about 400 other residents safely evacuating the burning building prior to collapse. It was reported that ongoing reconstruction work at this site had accidentally ruptured a gas line, which ignited and fueled this fire.

Figure 2.3 Collapse of Burning Apartment Block in St. Petersburg, Russia

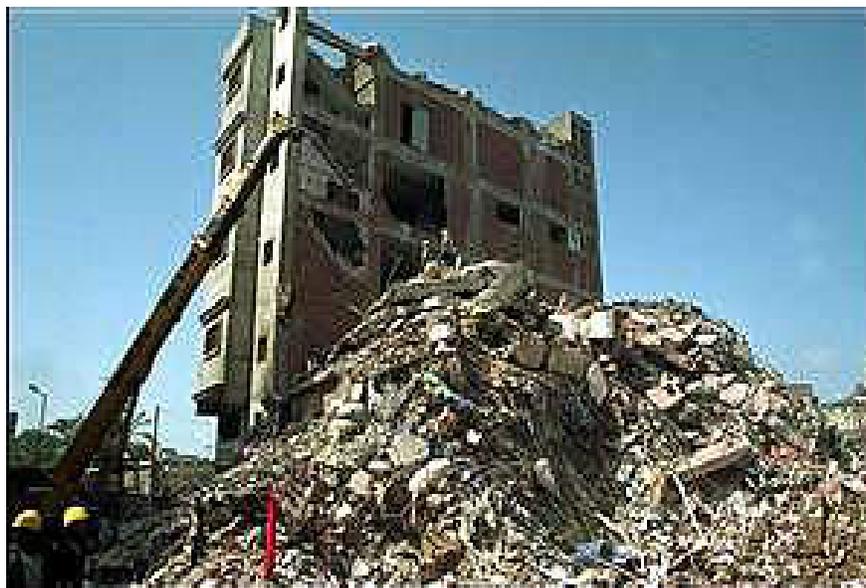
A fire-initiated collapse of a 6-story reinforced concrete textile factory occurred in Alexandria, Egypt on July 19, 2000 (Reuters News, 2000; BBC News, 2000). The fire started in the storage room at the ground floor. Fire extinguishers were non-functional, and the fire spread quickly before firefighters arrived. Approximately nine hours after the start of the fire, when the blaze seemingly was under control and subsiding, the building suddenly collapsed, killing 27 people. Figure 2.4 shows a photograph of this collapse.

Figure 2.4 Collapsed Textile Factory in Alexandria, Egypt

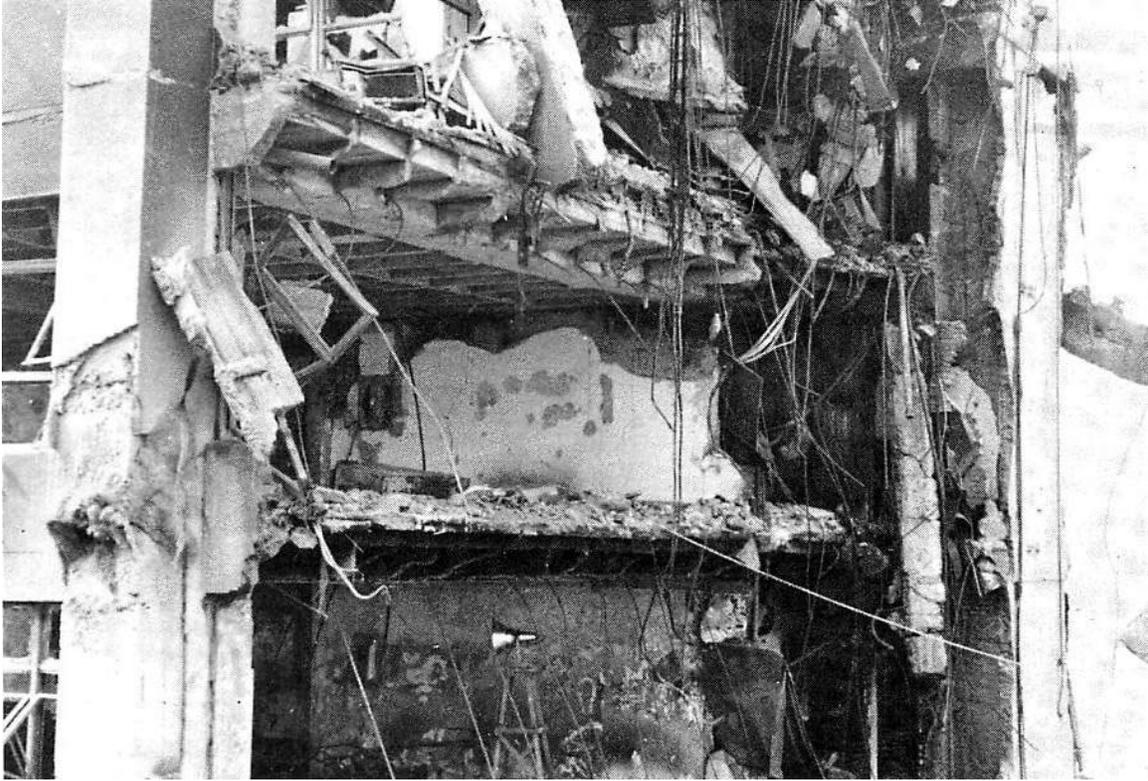
On May 21, 1987, Sao Paulo experienced one of the biggest fires in Brazil, which precipitated a substantial partial collapse of the central core of the CESP Building 2. This was a 21-story office building, headquarters of the Sao Paulo Power Company (CESP). Buildings 1 and 2 of this office complex were both constructed of reinforced concrete framing, with ribbed slab floors. According to Berto and Tomina (1988), these two buildings had several unique internal features and contents. Both buildings retained their original wood forms used for pouring the concrete floor slabs. Low-height plywood partition walls were also installed in the interiors. The ceiling in CESP 1 was made of plywood attached to the wood forms, while plaster tiles covered the ceiling in Building 2. Both buildings had automatic fire detection and manual fire alarms, but no automatic sprinkler system. Six footbridges connected these 2 buildings to permit convenient pedestrian access at various levels across a separation distance of 9.5 m.

The CESP fire started on the fifth floor of Building 1 from electrical causes, and progressed rapidly upward due to the combustible (wood) ceilings, the underlying formwork, and lack of adequate compartmentalization. Due to the severity of the Building 1 fire and other factors, it not only spread within this building, but also to the companion Building 2. The subsequent fires in CESP 2 ignited simultaneously on several floors due to the high thermal radiation from the original CESP 1 fire. In the presence of similar combustible partition walls and wood floor formwork, the CESP 2 fire also spread quickly. Firefighting efforts in both buildings were unsuccessful. Approximately two hours after the beginning of the fire in CESP 2, its structural core area throughout the full building height collapsed. This collapse was attributed to the thermal expansion of the horizontal concrete T-beams due to fire exposure. This led to the fracture of the vertical framing elements and their connections in the middle of the building, and the subsequent progressive loss of gravity load-carrying capacity (Figure 2.5). After the Building 2 collapse, the fire in Building 1, which was burning out, then re-ignited in floors 1-4 due of the flaming debris pile on the lower levels from Building 2. It was reported that this entire incident, from the original fire ignition in Building 1, spread to Building 2, the collapse of CESP 2 core, and the final re-ignition and burning of the lower floors of Building 1 lasted a total of about seven hours. The fire occurred in the evening and no casualties were reported.

Figure 2.5 CESP 2 Core Collapse in Sao Paulo, Brazil

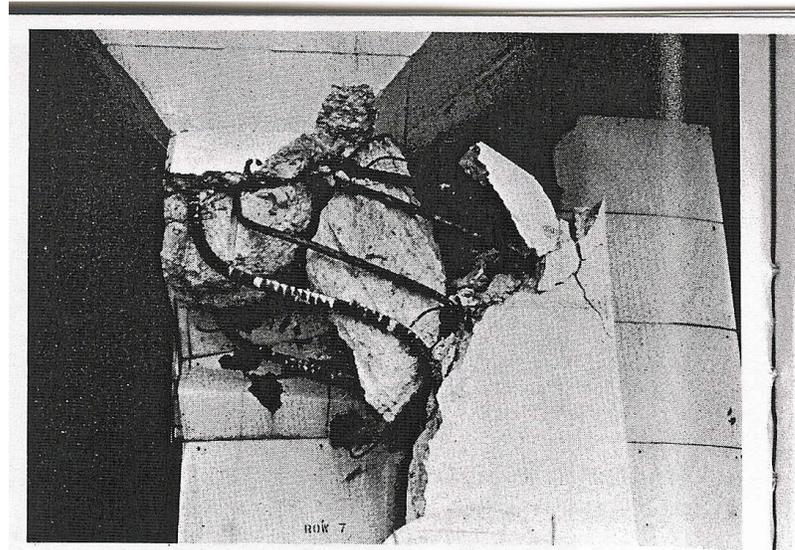
A partial roof and column collapse of the Military Personnel Record Center occurred on July 12, 1973 (Sharry, et.al., 1974). This was a large 86 m by 222 m, 6-story office building constructed of reinforced concrete. The building was located in Overland, MO and was built in the late 1950's. Sprinklers were present only on the first and second floors. The fire was reported to have started on the 6th floor. Due to the high fuel load of 21.7 million record files stored on the 6th floor, the fire burned out of control for 20 hours. The fire was finally extinguished after 4 days. The roof collapse began after approximately 12 hours of fire exposure, and involved 30% of the roof slab above the estimated point of fire origin. Subsequently, most of the remaining freestanding columns on the 6th floor collapsed. Minimal fire damage was experienced below the 6th floor. The collapse and damage were later attributed

to the large horizontal expansion of the 18 cm thick, conventional concrete roof slab that was supported by 41 cm reinforced square-tied columns. There were no expansion joints in the floors or roof. Lateral roof displacements of almost 60 cm occurred in one corner. Figure 2.7 shows the extent of the sixth floor horizontal deformation and damage to the concrete columns due to thermal expansion of the roof. The damage to the columns appeared to be analogous to the brittle column failures that have often occurred during earthquakes.

Figure 2.7 Large Lateral Deformations and Failure of Columns at Sixth Floor of Military Personnel Records Center

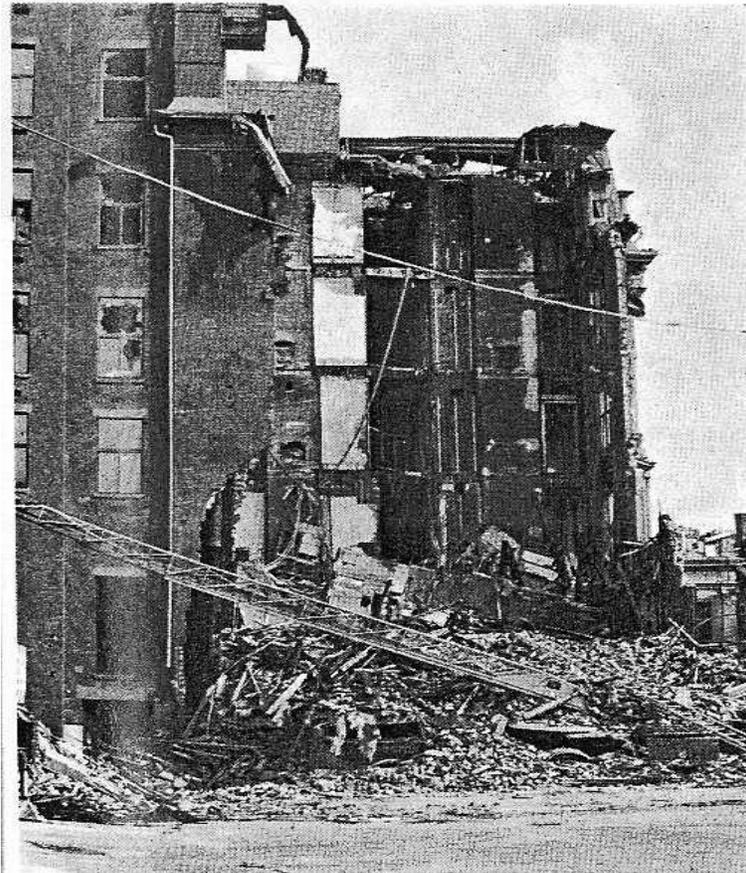
Another fire collapse occurred at the historic Hotel Vendome in Boston, MA. Built in the late 19th century of masonry and cast iron, this 5-story building was being renovated when a fire started at on June 17, 1972. After burning for almost 3 hours, all five floors in a 12 m by 13.7 m section collapsed (See Figure 2.8). This incident and the subsequent investigation were described in the *NFPA Fire Journal*, (January, 1973). Ongoing renovation work had caused excessive stresses on the bearing wall under a cast iron column, which was apparently already on the verge of overloading before the fire event.

Figure 2.8 Boston Vendome Hotel Collapse

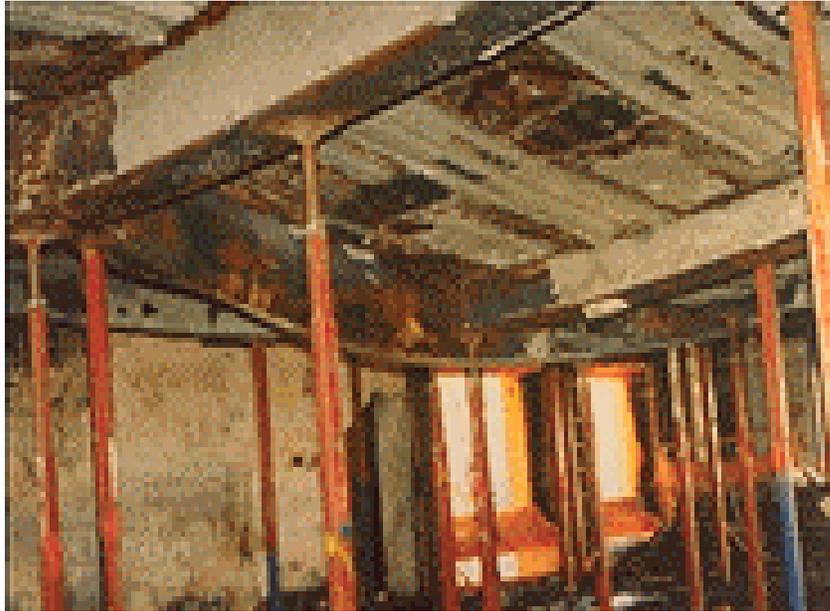
The 1980 MGM Grand Hotel fire in Las Vegas (Clark County Fire Department, 1981) killed 84 people, injured another 679 people, and caused hundreds of millions of dollars worth of property damage (Clark County Report). The First Interstate Bank (Klem, 1988) (4 floors burned out) and One Meridian Plaza (Klem, 1991) (9 floors burned out) in the US, and the Mercantile Credit Insurance Building and Broadgate fires in the UK (Newman, et al., 2000) are notable examples of excellent overall structural integrity under adverse fire conditions. Some casualties and major economic losses were still incurred in these steel-framed buildings. Complete burnouts of several floors destroyed the interior contents and caused substantial and permanent floor sagging and steel beam distortions, as would be expected after a long, severe fire exposure. In the One Meridian Plaza fire, deflection of main support beams were recorded as large as 46 cm, and one entire area of the 22nd floor had deformed by 1.2–1.5 m. (See Figure 2.9). All the buildings listed in Table 2.2, with the exception of One Meridian Plaza, were repaired and returned to service. After extensive investigations and studies, One Meridian Plaza was dismantled for economic reasons.

Figure 2.9 One Meridian Plaza Interior Fire Damage

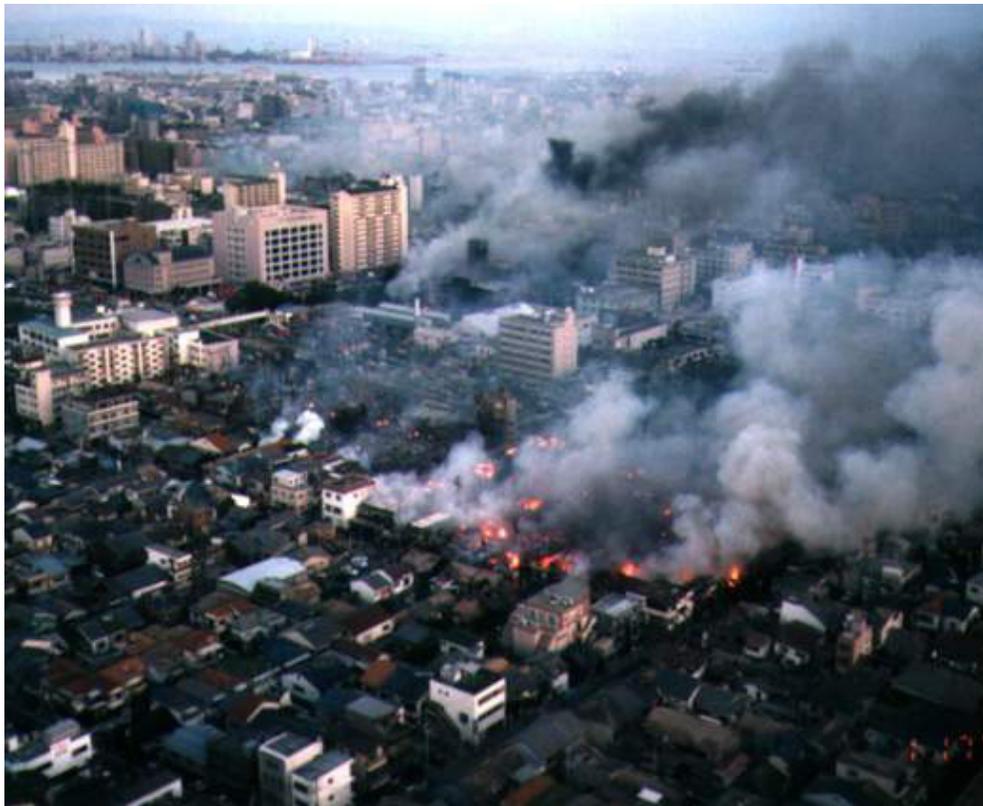
Approximately 100 fires started within minutes of the quake, primarily in the densely populated, low-rise residential areas of Kobe, Japan. It was reported that several large conflagrations had developed within 1 to 2 hours, with a total of 142 fires and numerous collapses and destruction of mostly low-rise, residential/commercial buildings of simple wood construction. Figure 2.10a and 2.10b shows pictures of the many fires in Kobe and their vast destruction after the 1995 earthquake (EQE Website).

Figure 2.10a Post-earthquake Fires in Kobe, Japan on Jan. 17, 1995

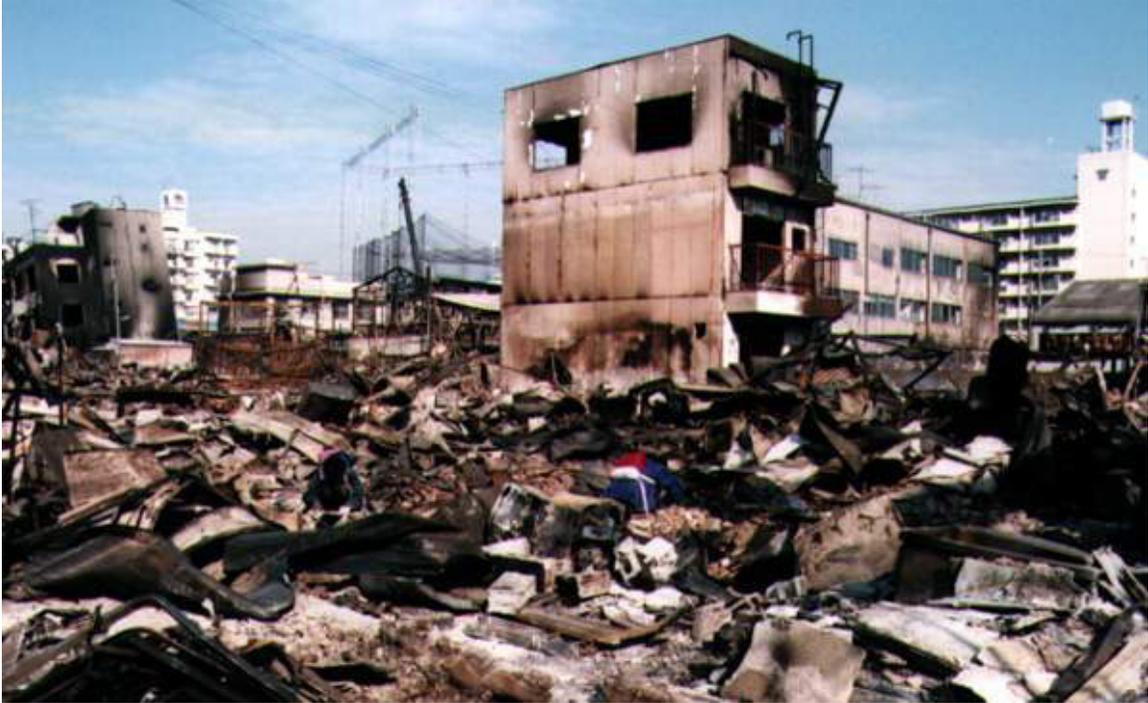
Figure 2.10b Burned Area in the Nagata Ward of Kobe
