NIST Technical Note 1476

Performance of Physical Structures in Hurricane Katrina and Hurricane Rita: A Reconnaissance Report

June 2006

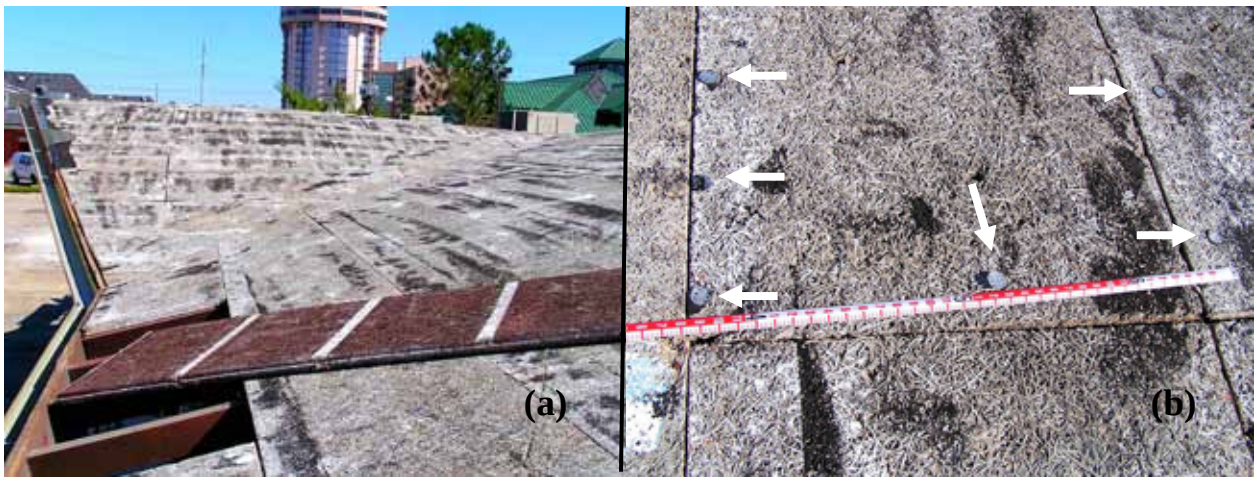
A small commercial building in New Orleans totally lost its bituminous roofing membrane. As shown in Figure 3-28a, this low-sloped roof system had a roof deck (which was also the membrane substrate) consisting of wood fiber cementitious panels that were held in place on the structural support only by their own weight. Note in the foreground of Fig 3-28a that one of these panels was lifted from its support at a roof overhang that was open to the walkway below. Such lifting of unattached wood fiber cementitious panel decks at roof overhangs was seen at a number of other buildings in the hurricane damage zones. For the roof in Figure 3-28a, the blow-off of the membrane likely[15] occurred due to uplift and tearing of the membrane base sheet from around the fasteners that secured the membrane to the wood fiber cementitious panels. A number of fasteners were found embedded in the wood fiber cementitious panels (Figure 3-28b); however, the number found was insufficient for proper attachment. Note, for example, in Figure 3-28b that the center of the wood fiber cementitious panel shown is essentially devoid of fasteners. Assuming that the fasteners shown at the left and right edges of Figure 3-28b are those that attached the edges of a membrane base sheet, then according to current guidelines two additional staggered rows of fasteners (for securing the center of the base sheet) would have been found embedded in the deck panel, instead of the single fastener shown. No evidence was seen that additional fasteners had ever been in place.

Figure 3-28 Blow-off of a bituminous roofing membrane from a wood fiber cementitious panel deck in New Orleans (a), precipitated by uplift and tearing of the membrane base sheet from around the fasteners (arrows) (b). An insufficient number of fasteners had been installed (Photo credit: Robb Smith, Amtech Roofing Consultants).

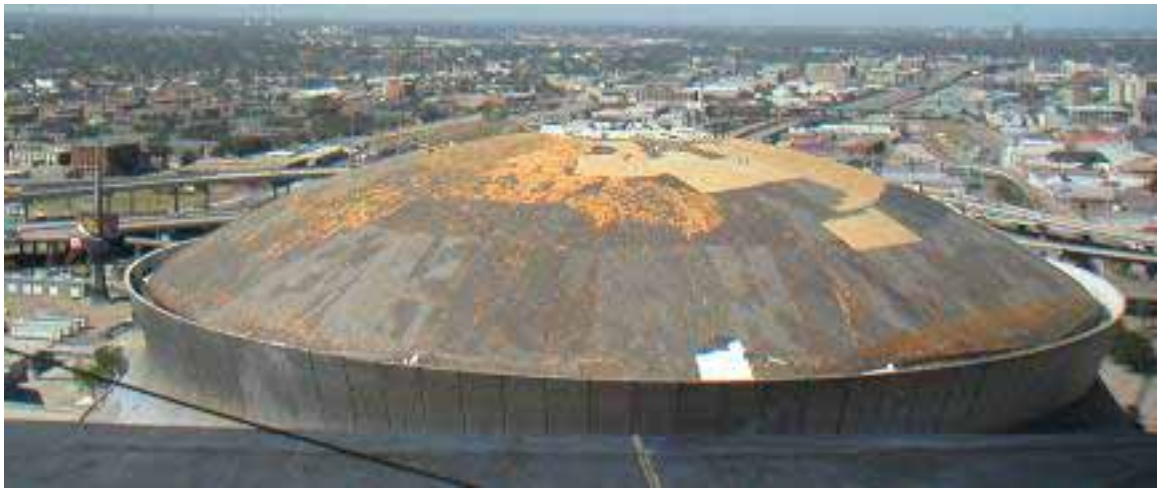
Figure 3-31 Louisiana Superdome. Gray areas are remaining polyisocyanurate insulation with a gray/black facer. Rust color is the original sprayed polyurethane foam (SPF). Tan is new SPF. The white area is a small section of white coated EPDM membrane that was not blown off. Before Hurricane Katrina, only the white coated EPDM membrane would have been visible on the roof (Photo credit: NIST).

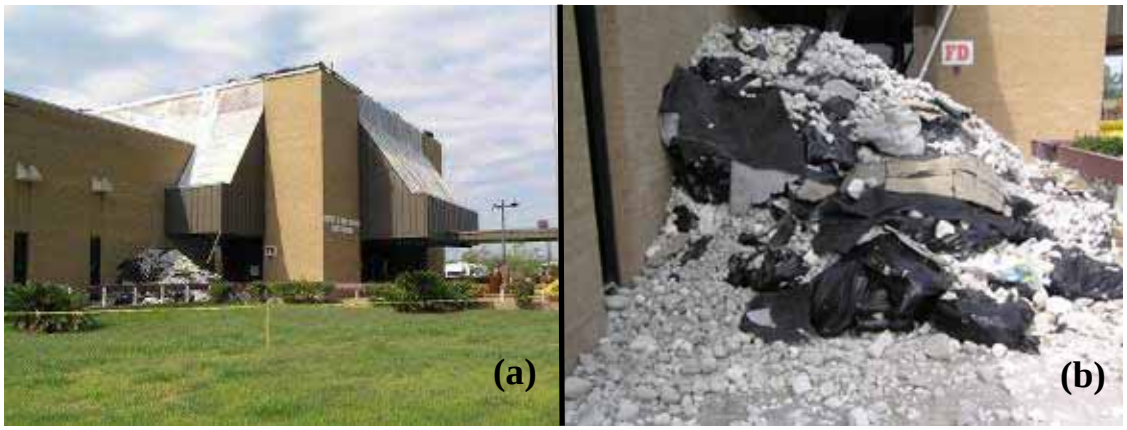
The Robert A. "Bob" Bowers Civic Center in Port Arthur, Texas, had a low-sloped bituminous membrane roof with steep sloping metal panel mansards along some sides of the building (Figure 3-41a). Both the membrane roofing and mansard paneling were damaged during Hurricane Rita, although specific details were not ascertained. The low-sloped roof could not be accessed at the time of the inspection. Also, temporary repairs had been made and some debris had been removed, as evidenced by no metal panels being found in the debris piles. Nevertheless, roofing debris at the building provided evidence that the low-sloped roof construction included a lightweight concrete fill, a layer of perlite board insulation that was mechanically attached to the fill, and a bituminous membrane that was adhered with hot asphalt to the perlite board. The lightweight concrete fill apparently[15] had been damaged, because the debris pile near the building's front entrance contained broken pieces of this component (Figure 3-41b). This roof failure caused extensive water damage to the building's interior.

Figure 3-41 Failure of low-sloped bituminous membrane roof along with a metal panel mansard roof at Robert A. "Bob" Bowers Civic Center in Port Arthur, TX (a). The low-sloped roof construction included a lightweight concrete fill that may have been damaged during Hurricane Rita (b) (Photo credit: NIST).

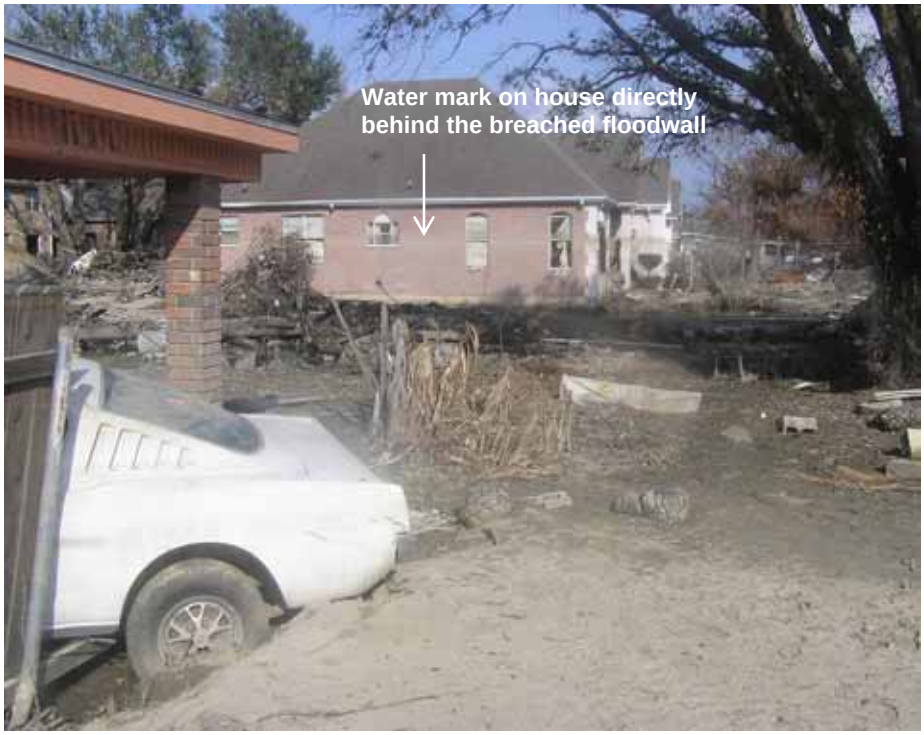
Figure 4-7 Water mark showing extent of flooding in area of New Orleans Parish directly behind the breached section of the floodwall (photo credit: NIST)

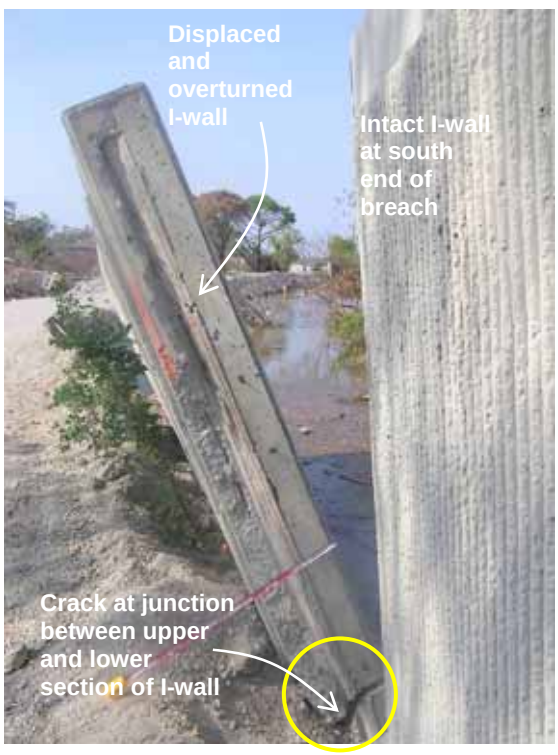
Figure 4-9 Cracked I-wall (photo credit: NIST)

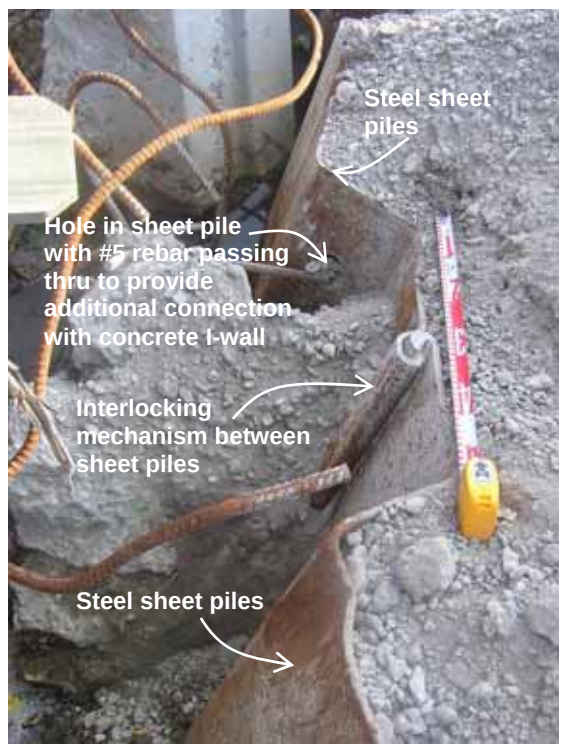
Water pressure was also sufficient to cause cracking of the concrete I-wall at the junction between the thin upper section and the enlarged lower section, as shown in Figure 4-9. Inspection of the intact section of the floodwall indicates that the location of the crack would be above the line of lateral soil support. Figure 4-10, taken at the north end of the breach where the concrete I-wall has been removed, provides some details of the interlocking steel sheet piles and arrangement of reinforcement for connection with the concrete I-wall.

Figure 4-10 Sheet piles details (photo credit: NIST)

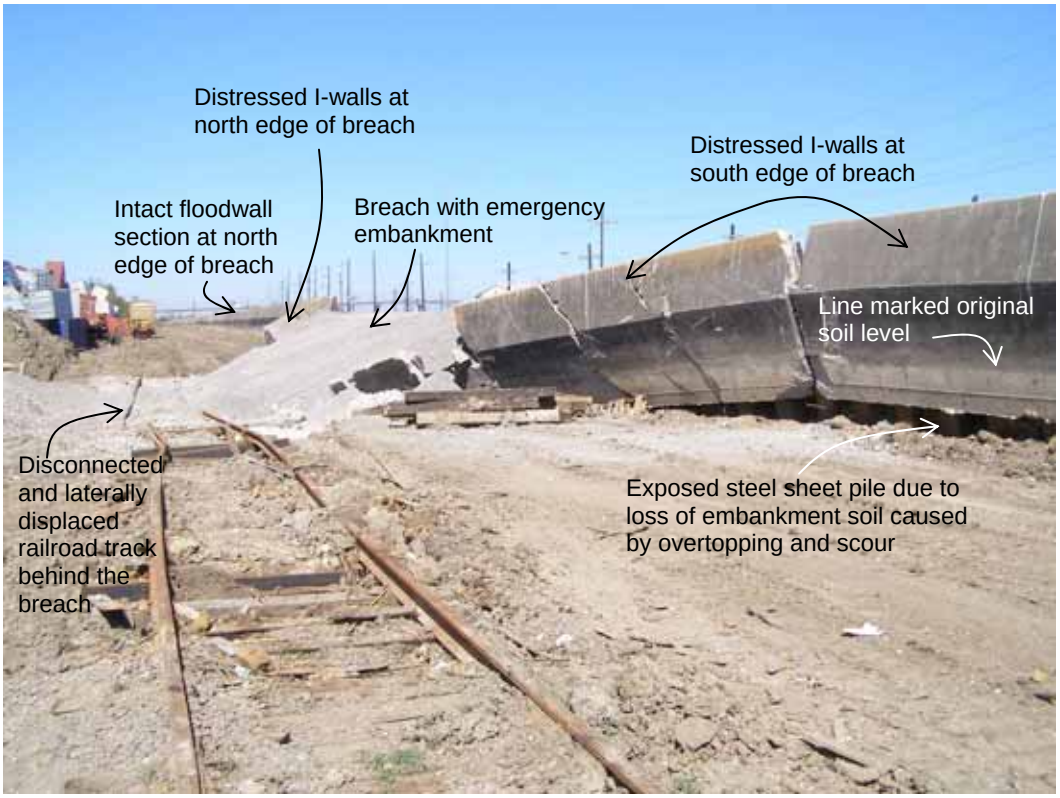
Figure 4-16 View looking north at the breach on IHNC at France Rd from the protected side (photo credit: NIST)

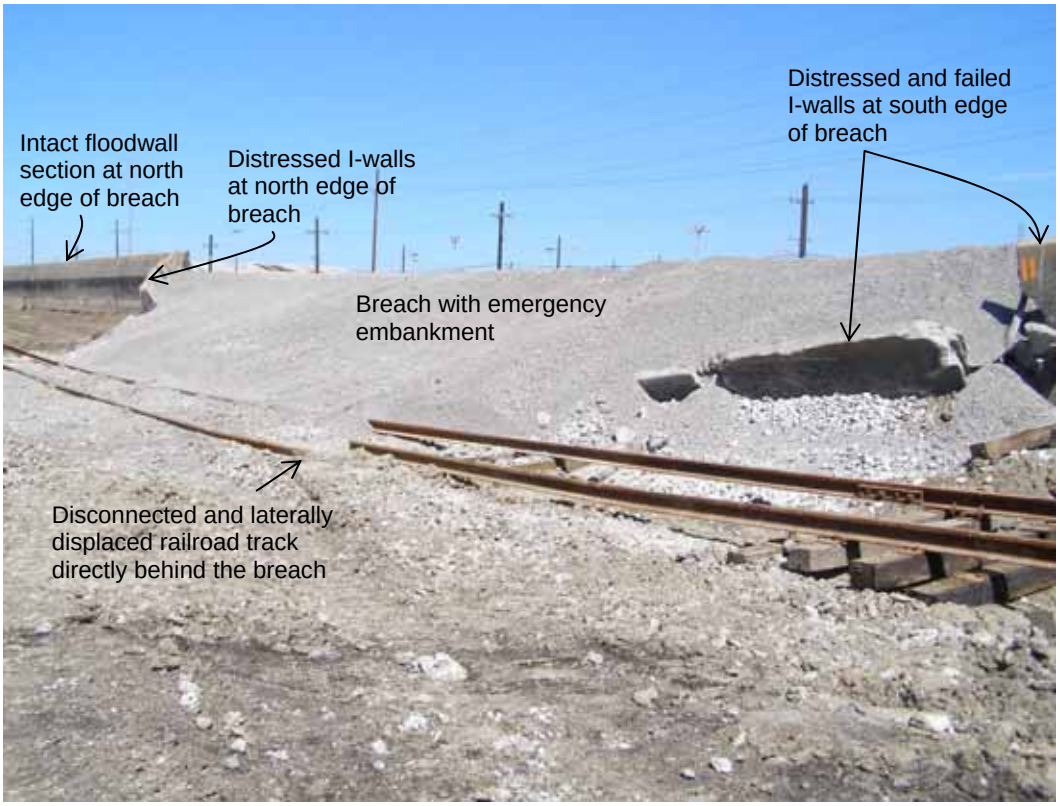
Figure 4-17 A closer view of the breach on the IHNC at France Road (photo credit: NIST)

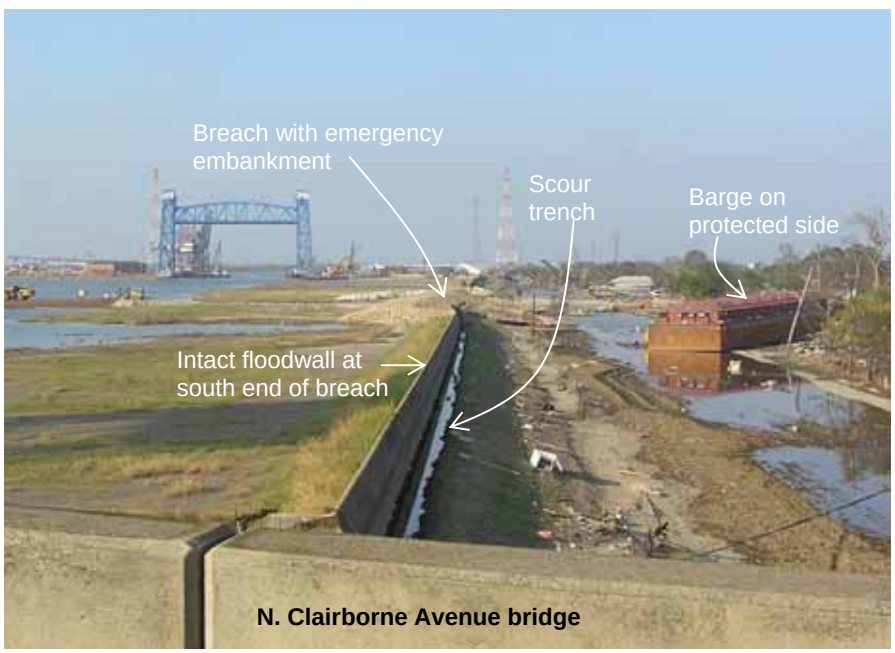
The floodwall construction at this breach is the same as the floodwall construction at the IHNC Lower Ninth Ward North breach, with similar concrete I-wall profile and steel sheet piles. Figure 4-24 shows the view looking north at the IHNC Lower Ninth Ward South breach, taken from the N. Clairborne Avenue bridge. This figure shows a scour trench, measuring approximately 6 ft wide and 8 ft deep, caused by overtopping along the inboard toe of the floodwall. This scour trench runs from the south edge of the breach to the N. Clairborne Avenue bridge (approximately 750 ft long). Figure 4-25 shows another view of the scour trench, looking south toward the N. Clairborne Avenue bridge from the protected side. Also shown in Figure 4-24 is a barge that was drawn through the breach and settled on the protected side of the canal near the south end of the breach. This barge apparently[15] impacted the floodwall at the south end of the breach (rust stain marks from the barge were observed by the ASCE team on the canal side of the floodwall), causing the concrete I-walls at this end to be broken into smaller pieces. The rest of the concrete I-walls that were part of the breached section appear to remain fully connected to the steel sheet pile even when overturned and uprooted from the embankment (Figures 4-26 and 4-27). The entire failed floodwall was pushed toward the protected side (in the direction of pressure), with the concrete I-walls pointing toward the protected side direction and the steel sheet piles pointing toward the canal. This suggests rotational failure caused by full outboard pressure and increased cantilever action from the loss of the supporting soil along the inboard toe due to overtopping scour as the likely[15] mode of failure[21].

Figure 4-24 View looking north at the IHNC Lower Ninth Ward South breach (photo credit: NIST)

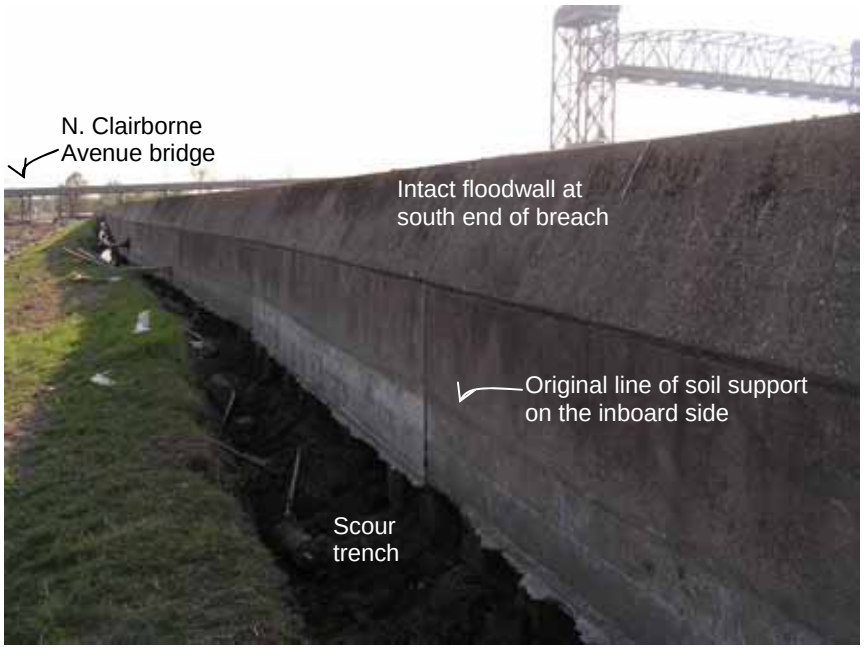
Figure 4-25 View looking south along the inboard side of the IHNC Lower Ninth Ward South breach (photo credit: NIST)

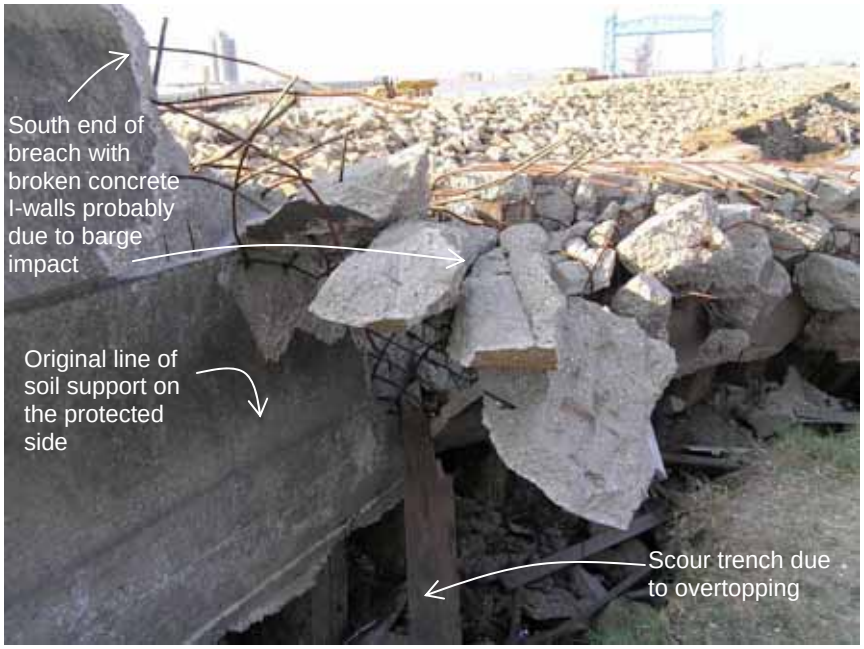
Figure 4-27 South edge of breach with broken concrete I-walls apparently[15] due to barge impact (photo credit: NIST)

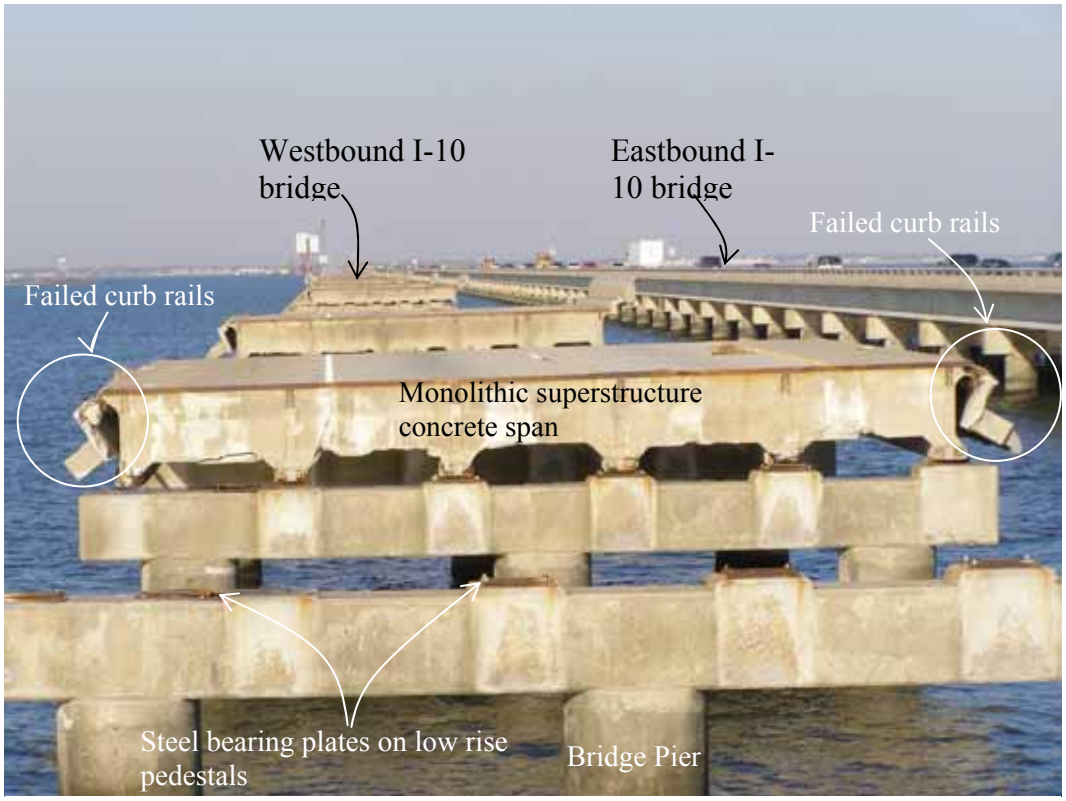
While the lack of restraint at the connection between the superstructure and the bridge piers contributed to the loss and misalignment of many of the I-10 bridges' superstructure spans, this type of construction does facilitate quick repair. The eastbound bridge was quickly returned to service by moving undamaged spans on the westbound bridge to fill the gaps in its superstructure, and by realigning and repairing the shifted and damaged spans. The eastbound I-10 bridge was reopened to two-way traffic on October 14, 2005, 34 days after being damaged by Hurricane Katrina.

Figure 4-31 View looking north from west abutment of I-10 twin span bridges over Lake Pontchartrain (photo credit: NIST).

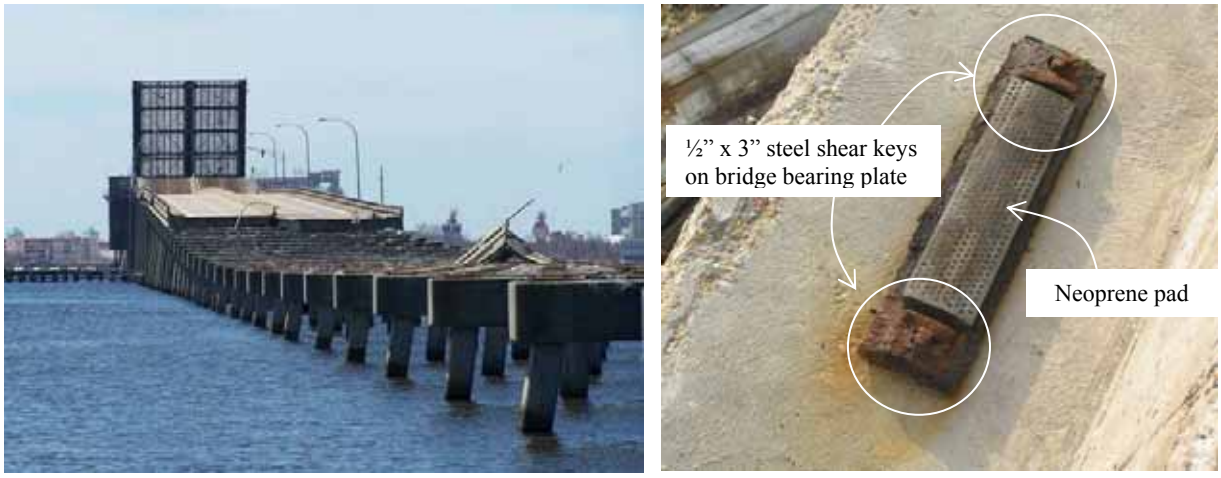
US-90 bridge. The US-90 bridge (Biloxi-Ocean Springs) is a 1.6 mile long, four lane, concrete bridge. Most of the bridge has low elevation except for the segment toward the middle of Biloxi Bay at the navigation channel where the superstructure was gradually raised higher to allow passage of boat traffic. The superstructure is comprised of simply supported spans with 42 feet long pre-stressed concrete I-girders. The substructure consists of multiple bents (concrete piers and cap beams). Each superstructure span was supported on the pier through steel bearing plates, which were bolted on top of the cap beam of the pier and cast into the bottom of the bridge girder. The steel bearing plate on top of the pier has low-rise steel shear keys (½ inch thick) at each end to provide restraint against lateral displacement (see Figure 4-43(b)). There is no provision for restraint against vertical displacement except for gravity.

partially or completely dropped into the water (see Figure 4-42). The ½ inch low-rise steel shear keys on the bearing plates were clearly unable to provide restraint against the combined uplift and lateral wave forces. The superstructure spans that were constructed at a higher elevation near the navigation channel, i.e. spans above an elevation of approximately 22 feet, were apparently high enough to avoid direct surge and wave actions and survived intact (see Figure 4-43(a)).

Figure 4-43 (a) Looking west toward Biloxi, spans above the surge line near the navigation channel survived, but the superstructure in the foreground was dropped off the piers (photo credit: J. O'Connor, MCEER), (b) A typical bearing plate from the US-90 bridge with ½ in. thick shear keys (photo credit: NIST).

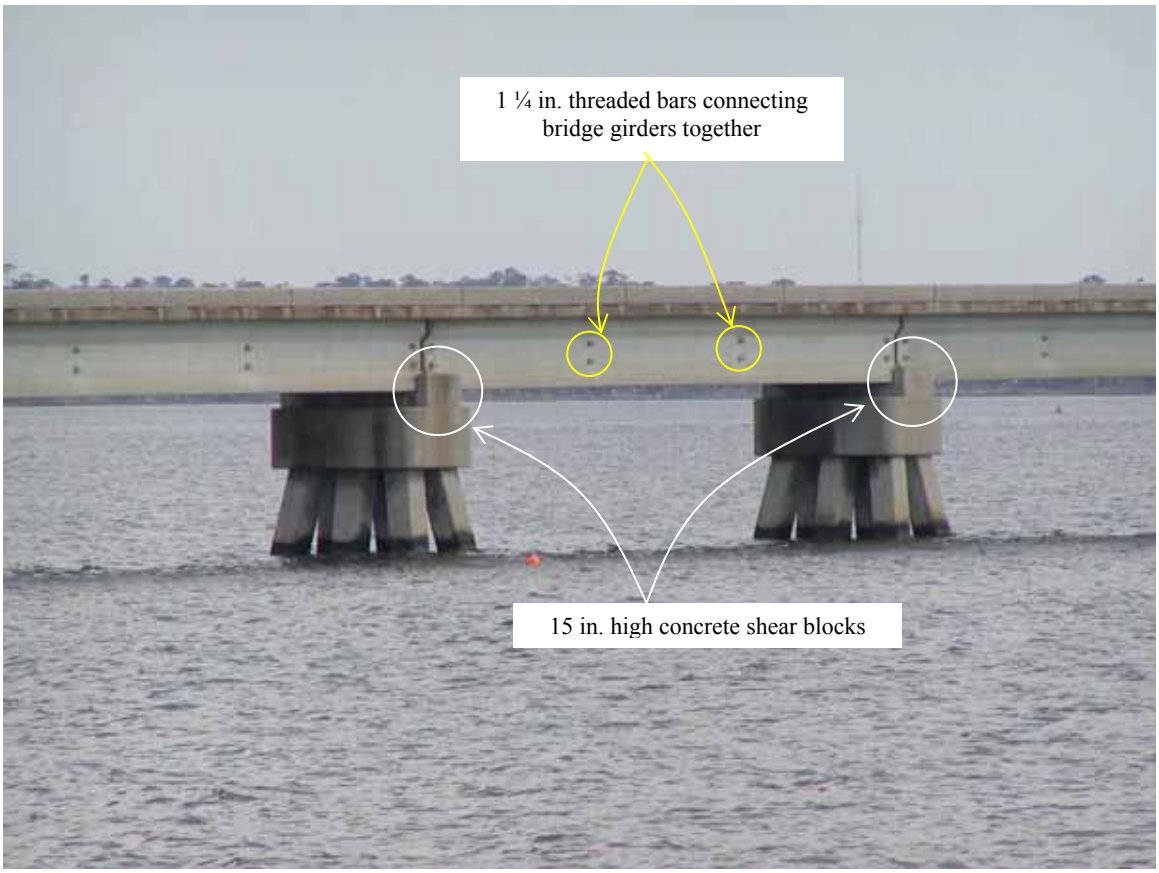
Figure 4-44 The CSX railroad bridge survived with minor damage, most likely[15] due to the presence of high shear blocks (photo credit: LA DOTD).

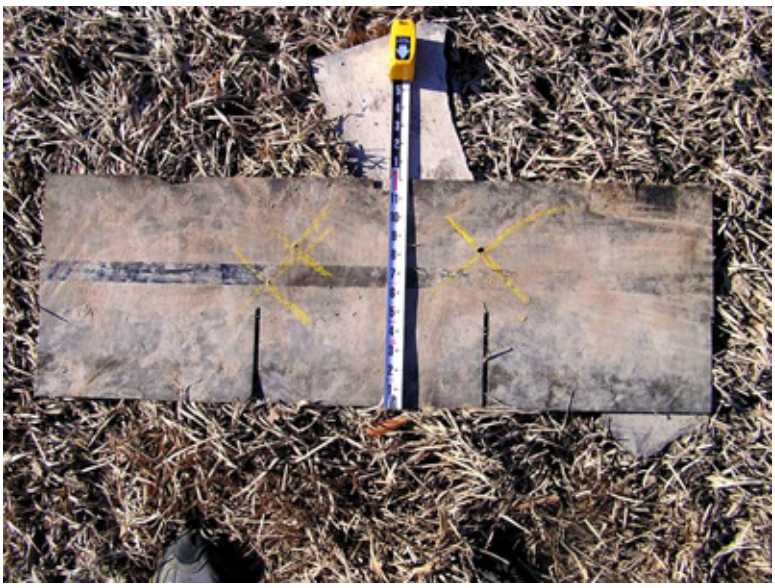
Figure 5-24 Example of a blown-off three-tab asphalt shingle that was clearly misapplied. The yellow Xs mark locations were the shingle was nailed in place. (Photo credit: Robb Smith, Amtech Roofing Consultants)
